Appendix I – Hazardous Materials and Contaminated Properties Supporting Documents

Re: Drilling Investigation
Subsurface Taconite Assessment
TH 53 Between Eveleth and Virginia, Minnesota
State Project No. 6918-80

TH 53 Between Eveleth and Virginia - Drilling Investigation Report

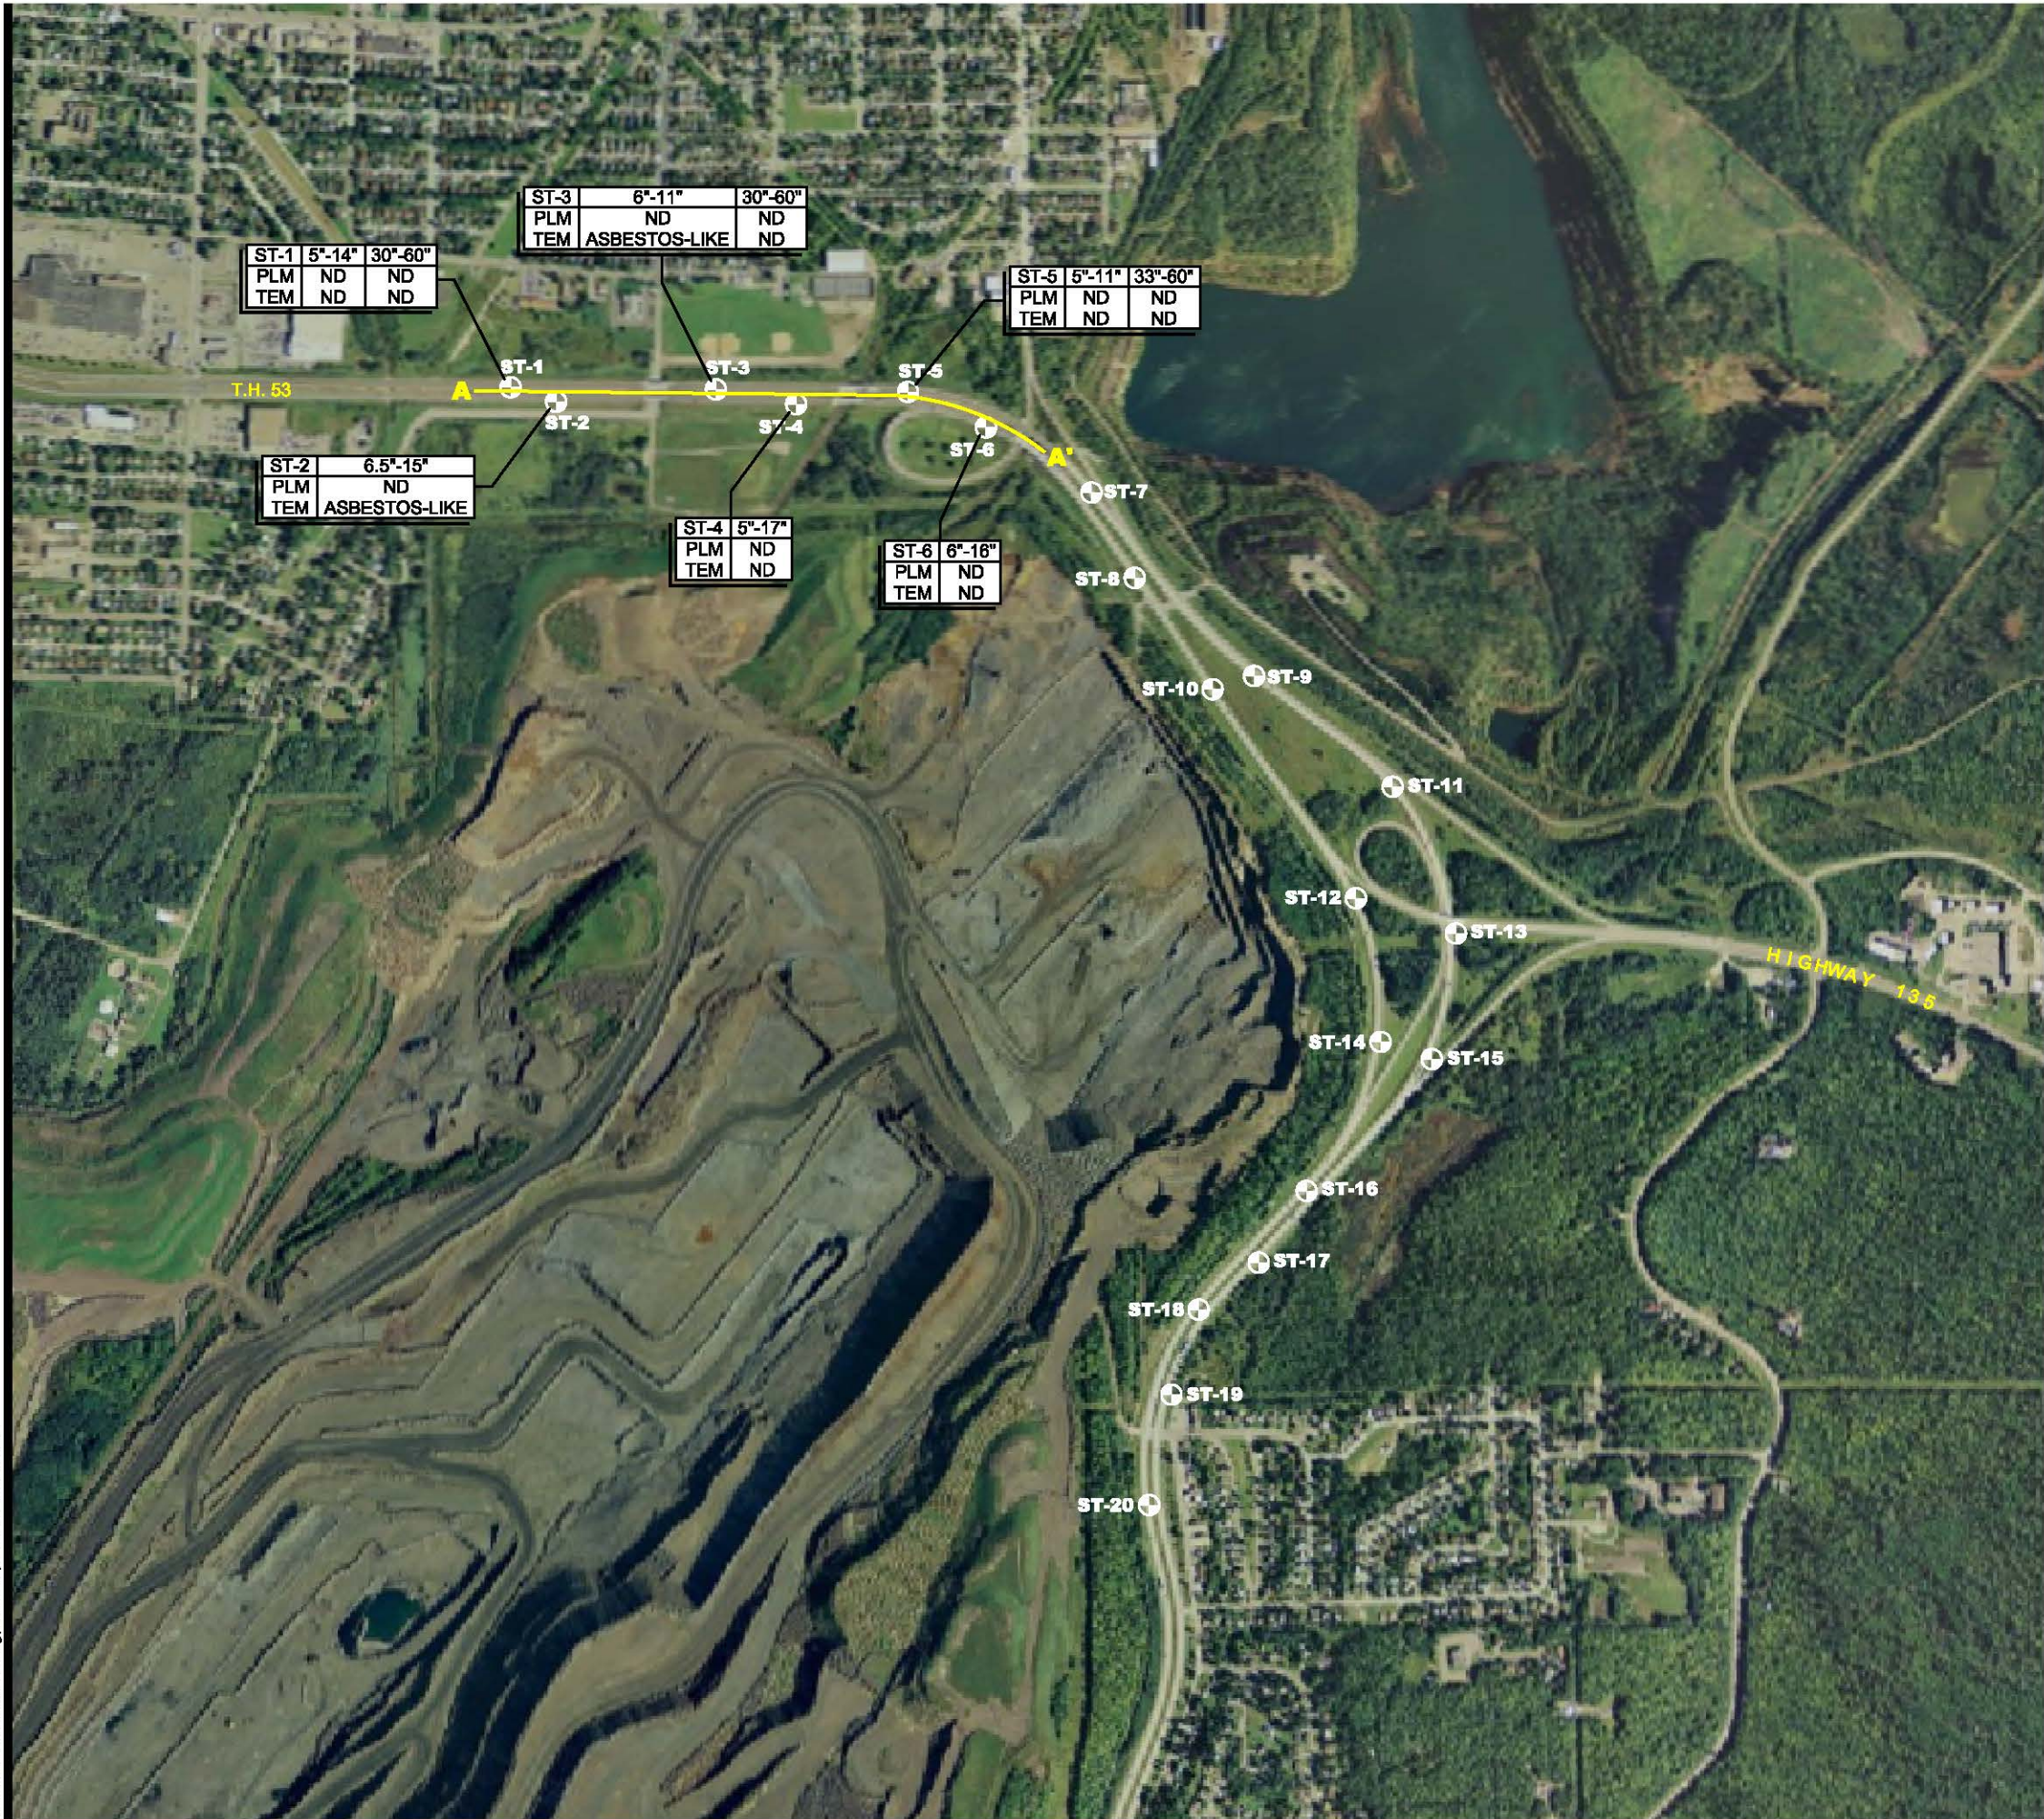
Bituminous pavement was encountered at seven (ST-1 through ST-6 and ST-8) of the 20 investigation locations at thicknesses ranging from 5" to 6.5". Concrete pavement was encountered at the remaining thirteen (ST-7 and ST-9 through ST-20) of the 20 investigation locations at thicknesses ranging from 8.5" to 9". Soil boring locations are shown on Figure 2.

- ⊕ DENOTES APPROXIMATE LOCATION OF SOIL BORING
- A—A'** CROSS SECTION AREA AND EXTENT OF IDENTIFIED TACONITE TAILINGS
- PLM POLARIZED LIGHT MICROSCOPY
TEM TRANSMISSION ELECTRON MICROSCOPY
ND NONE DETECTED

Taconite tailings were observed in soil borings ST-1 through ST-6. Taconite tailings were observed in soil borings ST-1 and ST-3 from beneath the bituminous to 60" bgs. Taconite tailings were observed in soil borings ST-2, ST-4, and ST-6, generally within the 5" to 17" bgs interval. Taconite tailings were observed in soil boring ST-5 within the 5" to 11" and 33" to 60" bgs intervals. Photographs showing the referenced intervals are included as an attachment. Taconite tailings were not observed in the remainder of the soil borings.

Please see the attached soil boring logs for a more in-depth summary of the observed materials. A soil boring profile (Cross Section A-A), depicting thickness and location of the identified taconite tailings, is attached as Figure 4.

The analytical results are summarized on the attached Figure 3. Laboratory analytical results of the samples indicated the following:

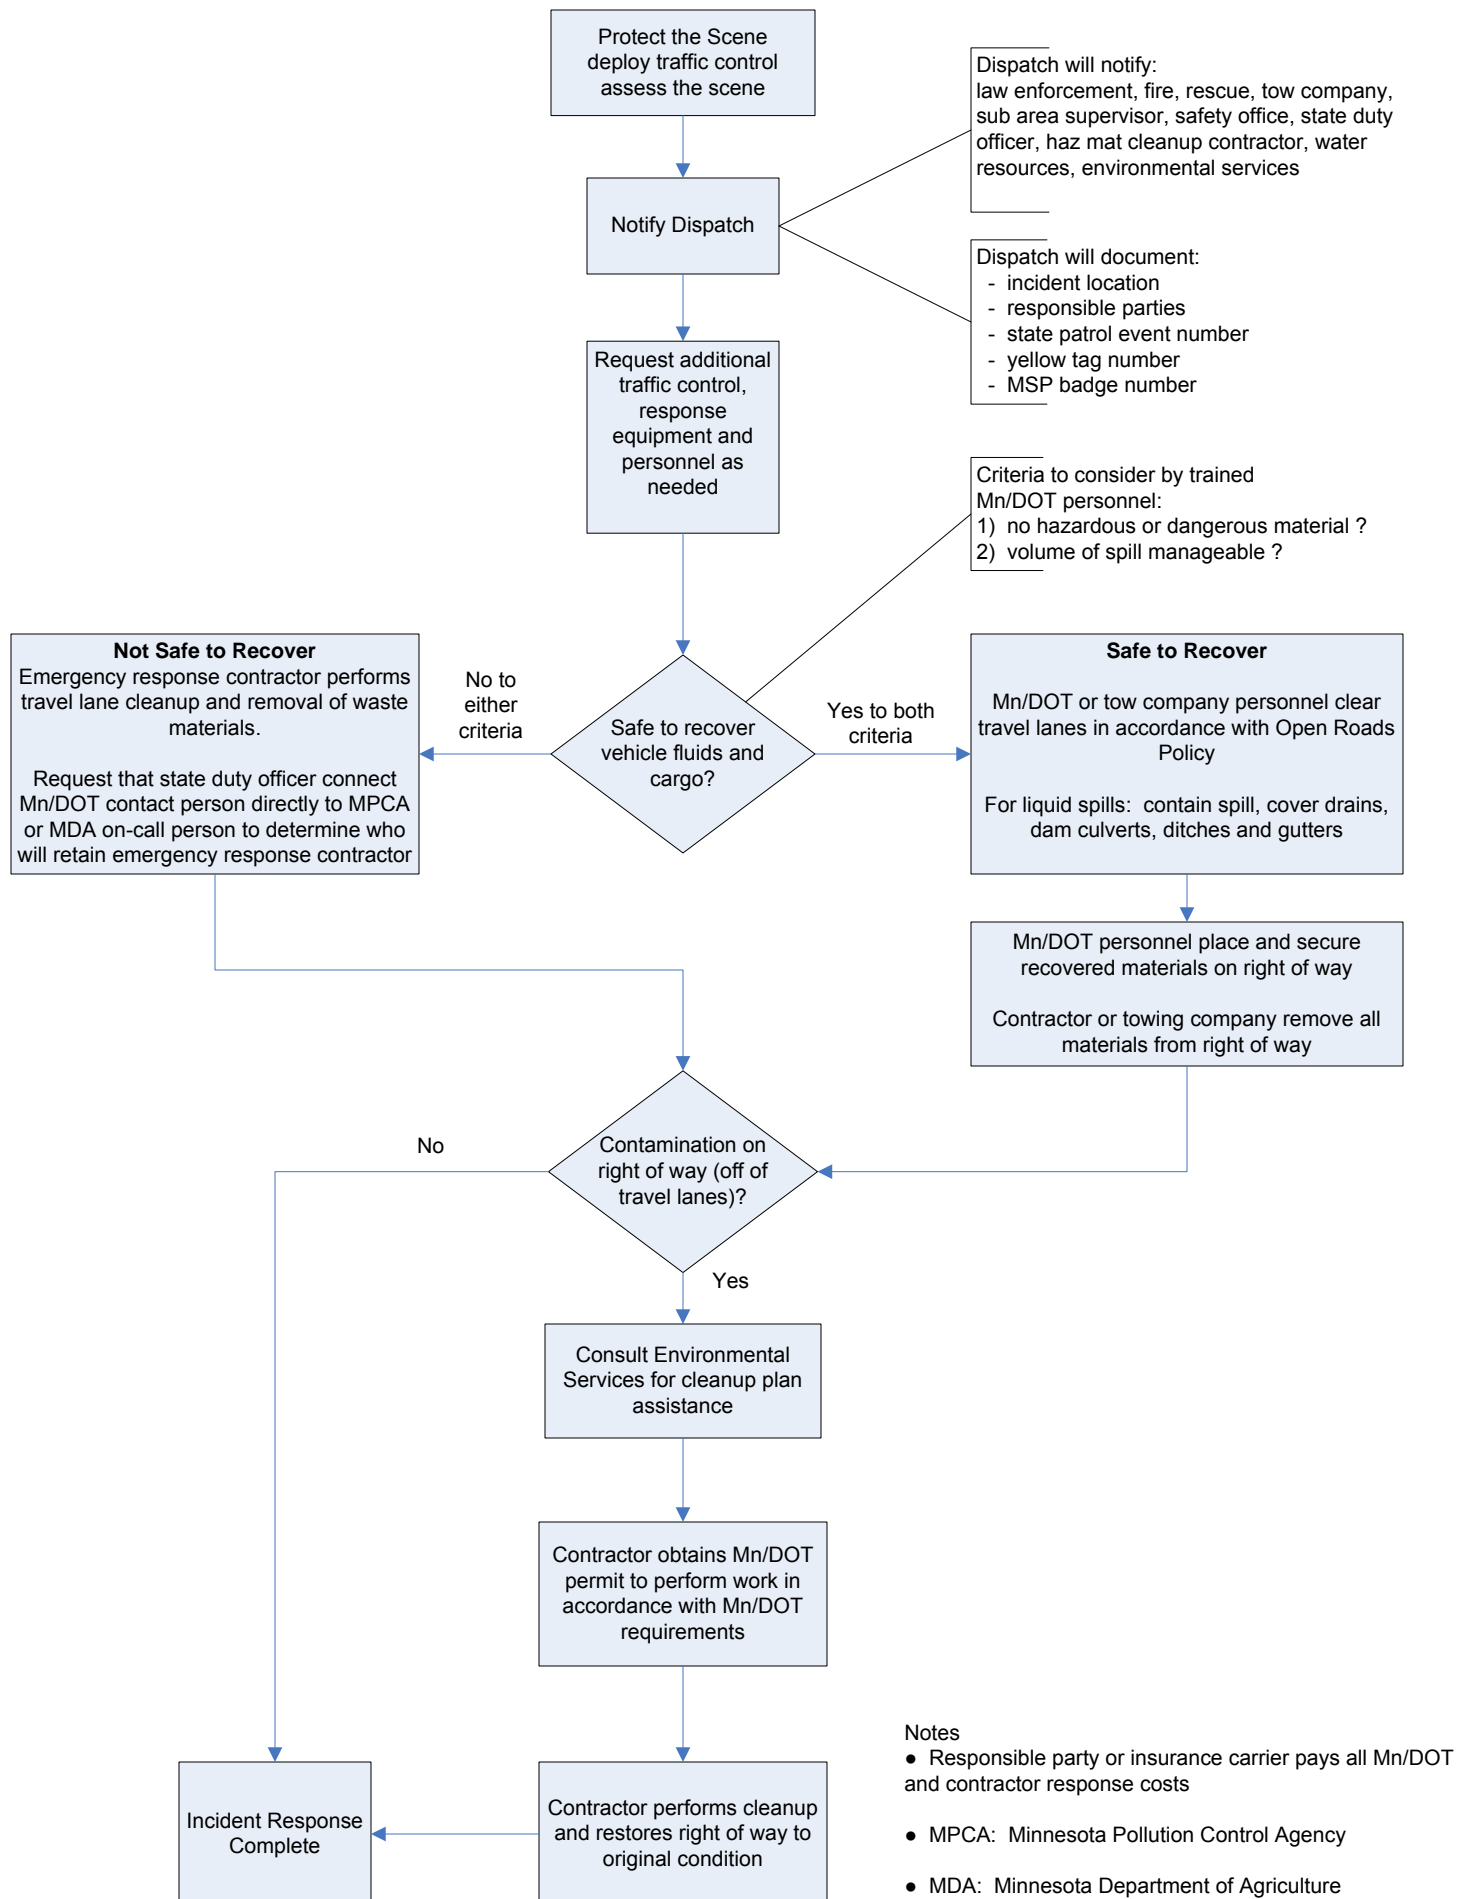
Roadway Incident Scene Response Procedure flowchart
